Technical Memorandum
Soil Resource Evaluation Pilot Study
Task Order #40
(Construction Report and Evaluation)

December 2008

CTSW-TM-08-172.40.1

California Department of Transportation
Division of Environmental Analysis
Storm Water Program MS27
1120 N Street, Sacramento, CA 95814

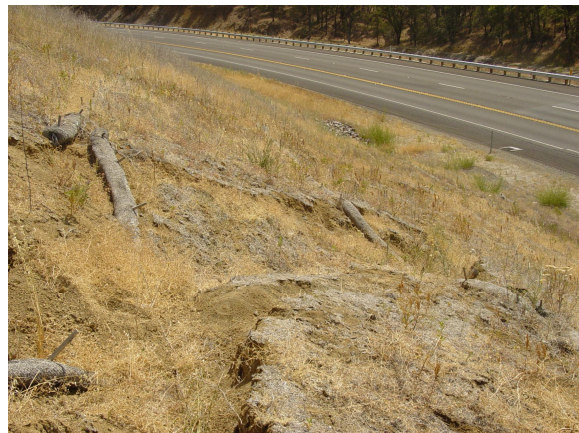
experienced minimal plant germination, indications of down slope soil erosion, and two fairly distinct areas of surficial slumping. Desiccation cracks were observed in the upper portion of the cut slope and the adjacent upslope area. Some of the cracks exceeded one foot in depth into the onsite clayey soils. The cut slope is at the toe of a natural ridge that ascends northerly onto adjacent properties. It appears that runoff of surficial waters from the adjacent properties discharged over the excavated slope and may have contributed to formation of the shallow soil slip problems at the *Clear Lake Site*.

Two areas of surficial slumps were observed on the slope face at the *Clear Lake Site* (see *Photo 1*). Three exploratory pits were excavated into these slumps so the geotechnical consultant could observe the failure surface and its depth. The interface between undisturbed soils and slumped soils was observed. This interface, the failure surface, was generally dipping out of slope and generally paralleled the bedding of the onsite shale. The failure surface extended to a maximum depth of approximately 3 feet in the main mass of the slumps.

To stabilize these slump areas and restore the slope face configuration, a repair scheme was proposed by the geotechnical consultant in the field. The stabilization method consisted of the excavation of two roughly horizontal benches across the slumps, one near the toe and one near the top of the slumps. The benches were excavated to a depth that disrupted the failure surface, and extended into the underlying undisturbed soils. The excavated soils were then replaced, moisture-conditioned, placed in lifts, and recompact as fill on these benches. The repaired slope face was track-walked to recompact the surficial soils to a minimum level acceptable to the geotechnical consultant.

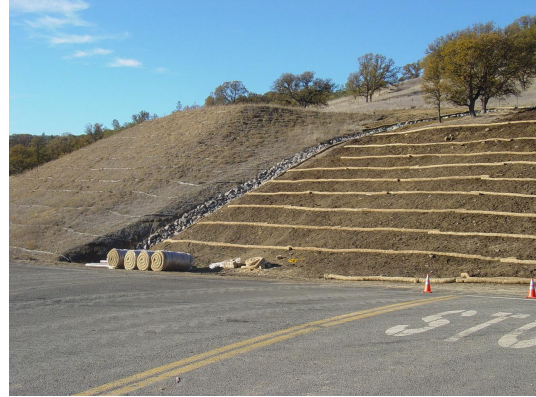
Storm water runoff from the adjacent upslope properties appeared to discharge over the *Clear Lake Site* cut slope. It was the opinion of the geotechnical consultant that this runoff on the slope face may have contributed to previous soil slippage and erosion problems at the site. The project team reviewed these site conditions and suggested adding a drainage channel at the top of the cut slope to intercept this surface flow and reduce offsite water influence on the site. This drainage channel was approximately 8 feet wide and 3.5 feet deep. This drainage channel was lined with permeable filter fabric and filled with dissipater-sized drainage rocks. This channel was

connected to the existing drainage discharge facilities system at the site and diverted most of the offsite surface water around project test site (see photo 4). While this surface drainage system diverted surface water runoff off the site, subsurface flow would still occur through the permeable channel liner.

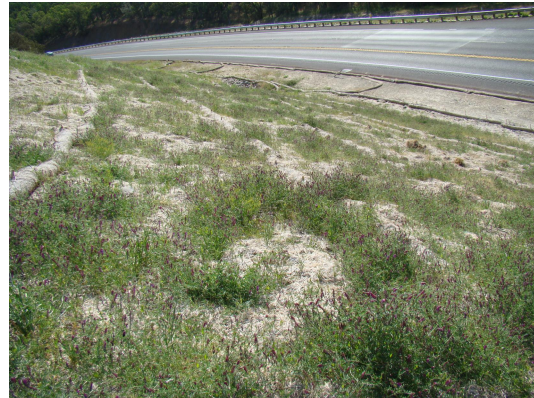
The *Clear Lake Site* slope was observed on three subsequent occasions by the project landscape architect/contractor to observe project performance. Site visits occurred two months, four months and 8 months after substantial completion of the construction activities. A photo of the slope four months after completion is included as *Photo 5*.

During the site visit two months after the completion of the construction, the site was experiencing a great amount of rainfall. There were no apparent indications of storm water runoff or erosion on the slope. The previously-failed areas that had been repaired appeared stable with no indications of slope movement. It was also observed that the adjacent properties showed signs of water runoff and erosion from the same rain event. In addition, the drainage channel at the top of the slope was observed and appeared to be effectively intercepting the water runoff from the adjacent upslope property. However, the hydroseeded mix was germinating but at a relatively slow rate. The project surficial soil compaction was also tested by probing by the landscape architect and it appeared that the soil compaction had slightly increased since initial construction but was still at an acceptable level for the project test program concept. The landscape architect/contractor and geotechnical consultant concluded that the project was performing better than anticipated, with the project showing minimal to no soil erosion and surficial rilling and substantially reduced storm water runoff. The project site also had no signs of soil surface sluffing or slipping as previously feared.

At the four-month site review climate conditions had changed, the *Clear Lake Site* slope soils were dry and the weather was becoming seasonally warm. The slope appeared to be performing as intended and had no indications of storm water runoff or soil erosion. Limited manual excavations were performed into the slope face which indicated that the soil profile had improved moisture-holding capacity with adequate levels of moisture to properly sustain plant growth. It was also observed that the soils on the adjacent property were very dry, and there was little to no moisture apparent in the near-surface soil profile. On the project slope, it was observed that the germination of the hydroseeded mix was less than expected. Apparently, the thickness of the mulch top dressing and straw combination was excessive and may have limited or delayed the germination of the hydroseed mix. However, it was also observed that some of the germinated hydroseeded plant material had drastically improved rooting depths extending 5 to 6 inches into the soil profile. Previous hydroseeded material had rooting depths of only 2 to 3 inches.

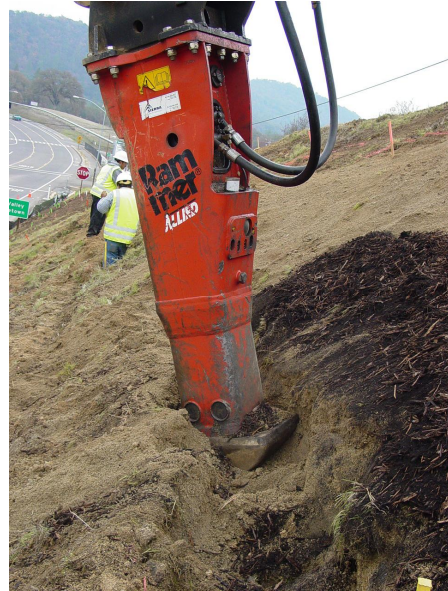
- b. The second modification used a Caterpillar track excavator with an impact breaker attachment to disturb the existing in-place soils by fracturing localized areas on the slope. The resultant depressions were approximately 1 foot wide and 2 to 3 feet deep. Disturbance of the granitic soils adjacent to the impact points occurred and extended approximately 3 feet laterally in all directions from the impact depressions. Amendments were incorporated into the disturbed areas and the slope surface was restored and recompact in place to an estimated rate of 85% relative compaction. These impact holes were spaced approximately 5 feet apart across the slope face in a random pattern of clusters. This technique is shown on *Photo 7*.

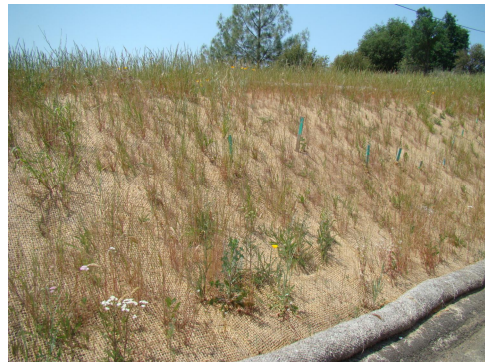
The *Lotus Site* was observed on three subsequent occasions by the project landscape architect/contractor to observe project performance. Site visits occurred two months, four months and 8 months after substantial completion of the construction activities. A photo of the slope four months after completion is included as *Photo 9*.

During the site visit two months after the completion of the construction, the site was experiencing heavy rainfall during a several-day precipitation event. There were no apparent indications of storm water runoff or soil erosion on the slope face. The slope had been entirely covered with jute net and observation of previous surficial soil slumps was very limited, but no indications of downslope movement were apparent. The plant material planted from containers were all living and in apparently good condition. Heavy rains precluded more detailed observations at that time, however, the landscape architect/contractor and geotechnical consultant concluded that the project was performing better than anticipated, with the project showing minimal to no soil erosion and surficial rilling. The project site also had no signs of soil surface sluffing or slipping as previously feared.

At the four-month site review the *Lotus Site* was observed to be performing as intended and had no indications of storm water runoff or soil erosion. Observations of the previous slope failure areas indicated no apparent signs of movement. The plant material from containers was generally thriving with only a minimal mortality rate. Two plants were excavated and were evaluated for their root growth. Both plants showed signs of deepened root growth because of the amended soils. However, the landscape architect noted that the germination of the hydroseeded mix was less than expected. Hydroseeding had been done prior to the cold winter weather and snow. The inclement weather was the reason for the slow germination, as suggested by seed manufacturer. This project should be rehydroseeded the following year so as to attain a proper evaluation of the hydroseeding techniques.

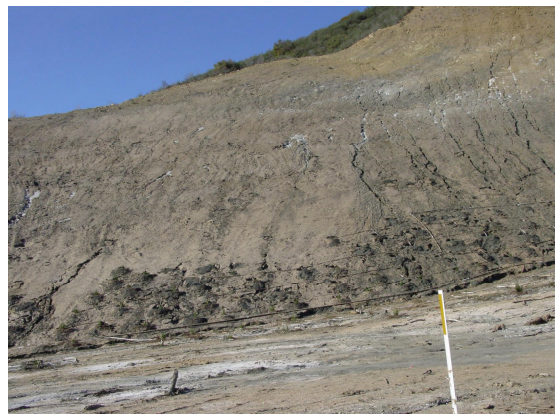
“*Templin Slope Test Site*” - The southern, steeper “slope” area consists of a cut slope with a gradient of roughly 2 to 1 (horizontal to vertical) (see *Photo 10*). The area treated with the *SRE System* as part of this *SRE Pilot Study* was approximately 320 feet by 80 feet.

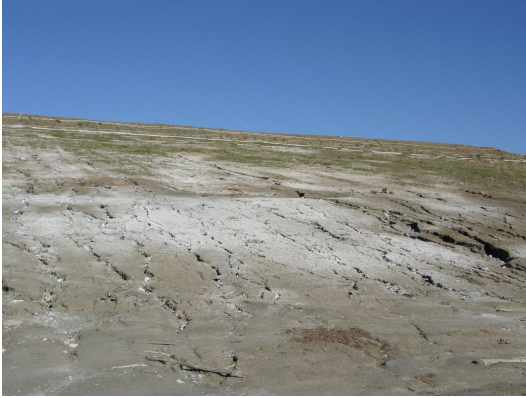
“*Templin Flats Test Site*” – The northern “flats” area consists of a graded slope with a relatively gradual gradient of roughly 5 to 1 (horizontal to vertical) (see *Photo 11*). The area treated with the *SRE System* as part of this *SRE Pilot Study* was approximately 120 feet by 120 feet.

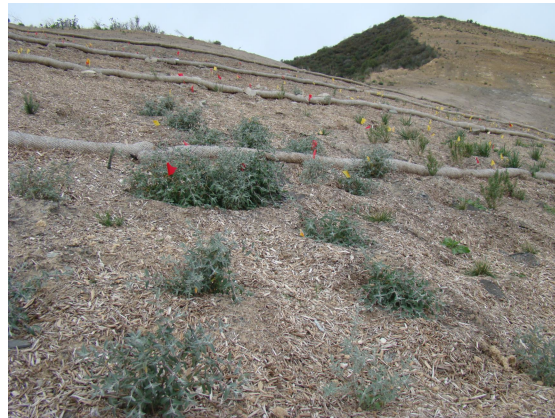
The *Templin Site* was observed on three subsequent occasions by the project landscape architect/contractor to observe project performance. Site visits occurred two months, four months and six months after substantial completion of the construction activities. A photo of the slope four months after completion is included as *Photo 13*.

During the site visits, there were no apparent indications of storm water runoff or soil erosion on the *Templin Slope* or *Templin Flats* areas. The plant material planted from containers was in good condition, however, the germination of the hydroseeded mix was less than expected. This was likely because it was hydroseeded late in the year and most of the seed went dormant in the summer period. The landscape architect/contractor and geotechnical consultant concluded that the project was performing better than anticipated, with the project showing minimal to no soil erosion and storm water runoff. The project site also had no signs of soil surface sluffing or slipping as previously feared. Container plant material was doing great and had plenty of new growth. Several plants were excavated and observed that the plant root structure had extended root structures deep into the soil profile. Also soil profiles were excavated and showed signs of moisture retention as compared to non treated soils adjacent project test site which no signs of moisture retention. Further monitoring is recommended to more fully evaluate the success of the application of the *SRE System* for the two *Templin Site* areas.
